RAY COUNTY DAM NO. A-1

RAY COUNTY, MISSOURI

MISSOURI INVENTORY NO. 11084

PHASE I INSPECTION REPORT
NATIONAL DAM SAFETY PROGRAM

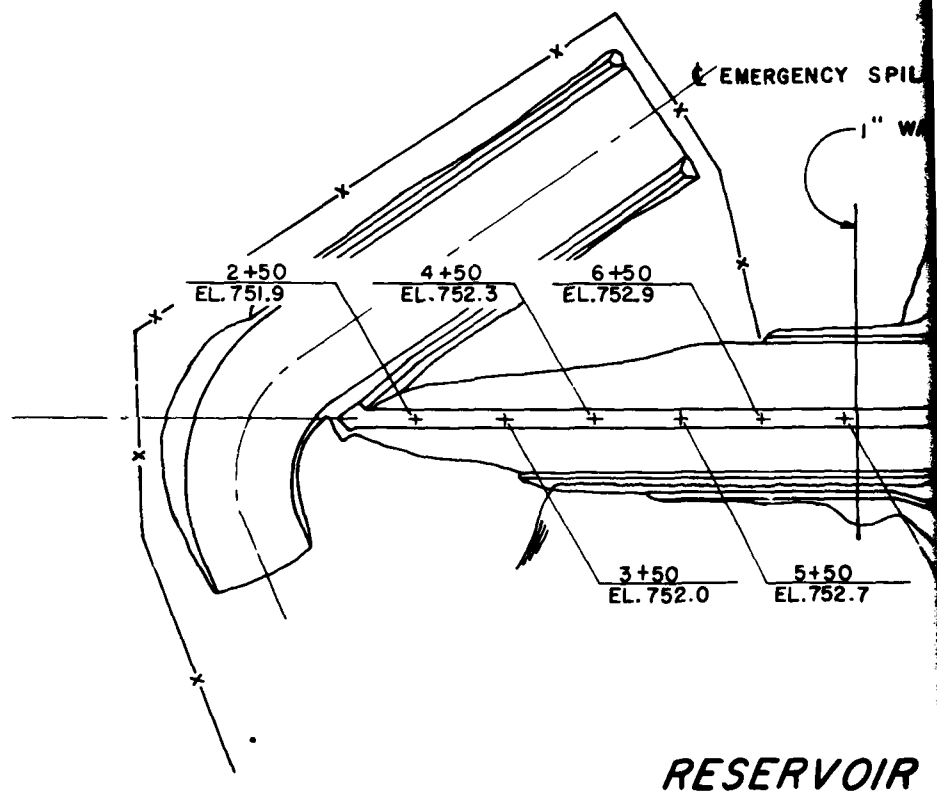
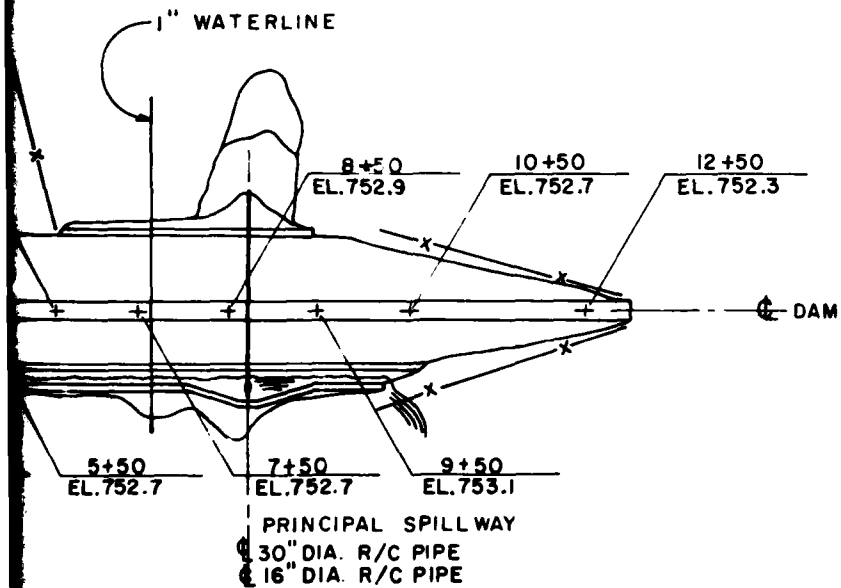
PLATE 3

RAY COUNTY DAM NO. A-1
PLAN

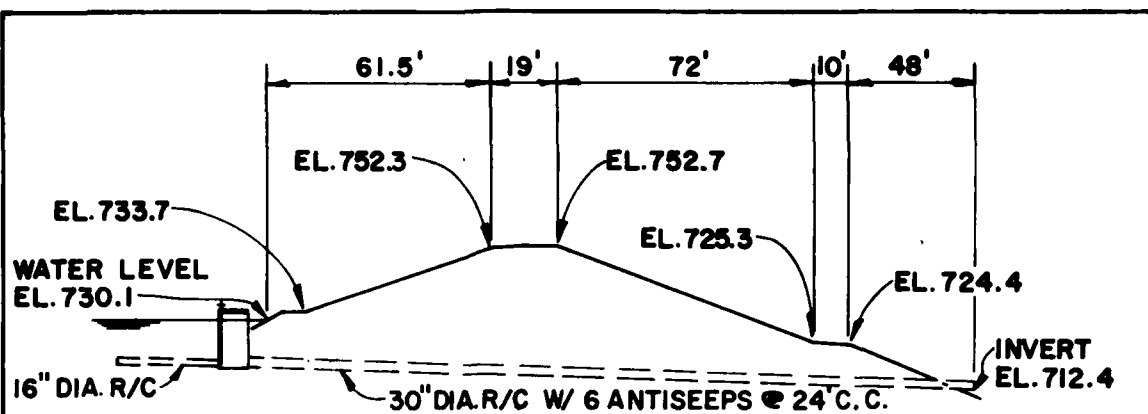
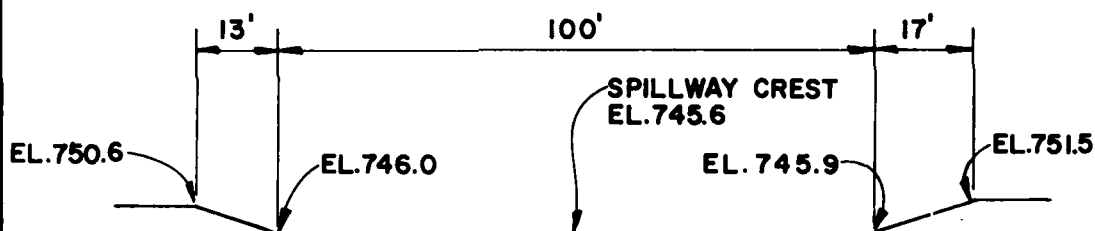
SECTION TAKEN AT APPROX. 8+70
TYPICAL

SECTION TAKEN LOOKING DOWNSTREAM
EMERGENCY SPILLWAY

RAY COUNTY DAM NO. A-1
TYPICAL & SPILLWAY SECTIONS
